DUCTILE IRON PIPE SURFACE CHARACTERIZATION AND PINHOLE FORMATION

**Prof. Dr. Fevzi YILMAZ,
Özgür CEVHER (M.Sc.) and Mustafa BAYRAKTAR (M.Sc.)**

ABSTRACT

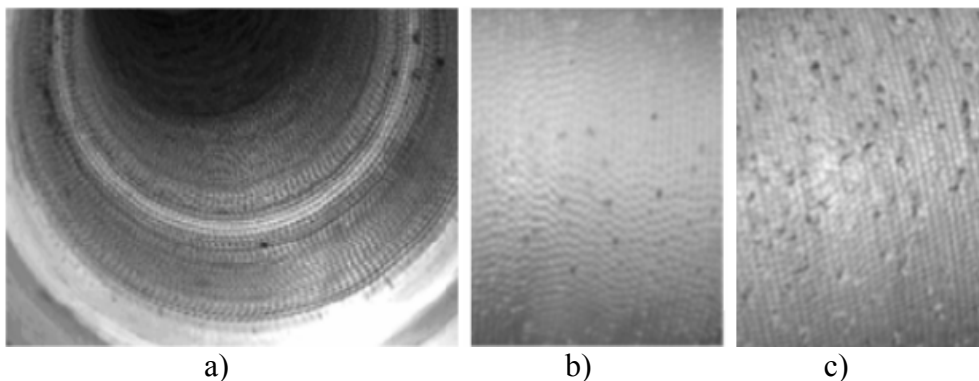
Pinholes are likely to occur on thinner pipe. Holes can be caused by an excessively high or low pouring temperature. One common cause of pinholes is moisture retained in the mould coating or some constituent of the coating that turns to a gas when the molten metal comes into contact with it. This gas, as well as gas generated from internal source of melt tends to migrate and the easiest path, in most cases, is through the molten metal. Surface and subsurface pinhole grows in competition with solid layer, into melt. The pore gains gas from the surface reaction, and loses it from its growing front. If growing front is entrapped by solid layer or if the surface of pinhole is covered by oxide, smooth pore shape becomes curved and twisted. However, when the molten metal is in the process of quick solidification and first solid layer forms immediately, the gas will become entrapped, curved as they emerge from the coating (Fig 1). Since layer formation rate or growth rate is very high in centrifugal casting (hundreds of $\mu\text{m}/\text{sec}$ in centrifugal castings, tents of $\mu\text{m}/\text{sec}$ in sand casting) cylindrical surface pinholes generally develop on pipes (Fig 2).

Figure 2. Steel mould (a) and ductile iron pipes (b-c) produced centrifugally. a) Steel mould with internal wavy zone to hold solidifying pipe. b) Surface of pipe produced under very high molten metal temperature (Moulds internal wavy zone pass to pipe surface. Pin pointing pinholes are clear). c) Surface of pipe produced under very low molten metal temperature (Moulds internal wavy zone can hardly be seen on the pipe. Curved cylindrical pinholes are clear).

Corrective measures include elimination of gassing possibilities; use of an exothermic pipe eliminator to promote unidirectional solidification and the appropriate pouring temperature possible without causing cold shuts. Shortly, pinhole defects can be avoided by taking below given precautions:

- a) Making the mould carefully and maintaining its temperature accurately,
- b) Using coating materials that contain less volatile mixture, less moisture and no free water of crystallization,
- c) Maintaining an accurate molten metal temperature,
- d) Taking the relatively high mould rotation speed.

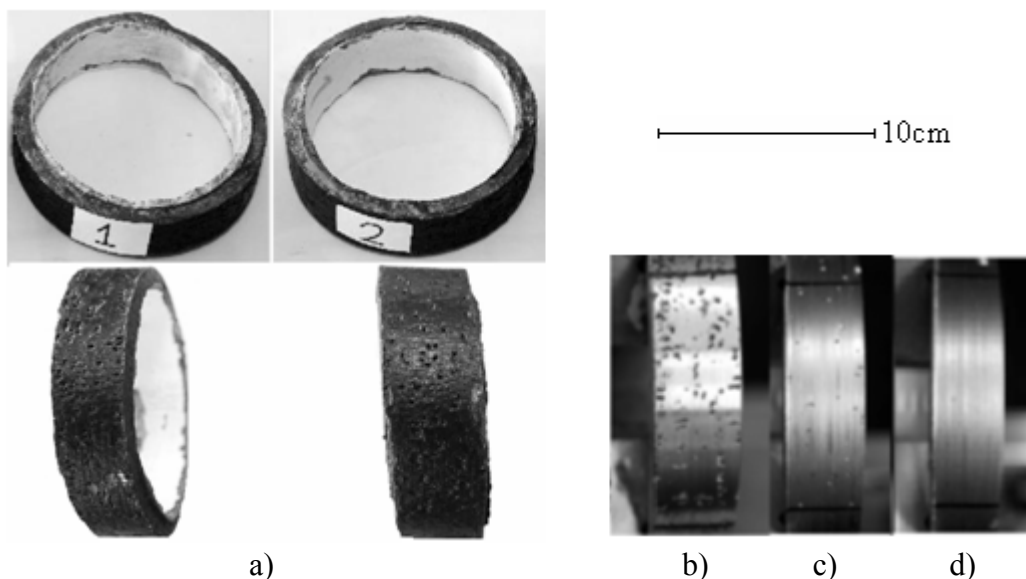
Surface topography, number, shape, volume fraction of pinholes in given area were examined. The specimens with machined layers up to 2mm of depth removed from surface gradually and at each stage pinholes were examined. One of the ductile iron pipe ring which has much pronounced pinholes are given in Fig 3a. Fig. 3(b-d) shows changing of surface topography due to machining.

Figure 3. Pinhole rich pipe rings and surface machining. a) Four ductile iron pipe ring samples (6mm alloy wall thickness, 3mm internal cement lining and external bitumen paint are evident. Note that under the bitumen paint thin zinc coating and surface iron oxide are available. b) 0,5mm depth machining, c) 1mm depth machining, d) 1,5mm depth machining.

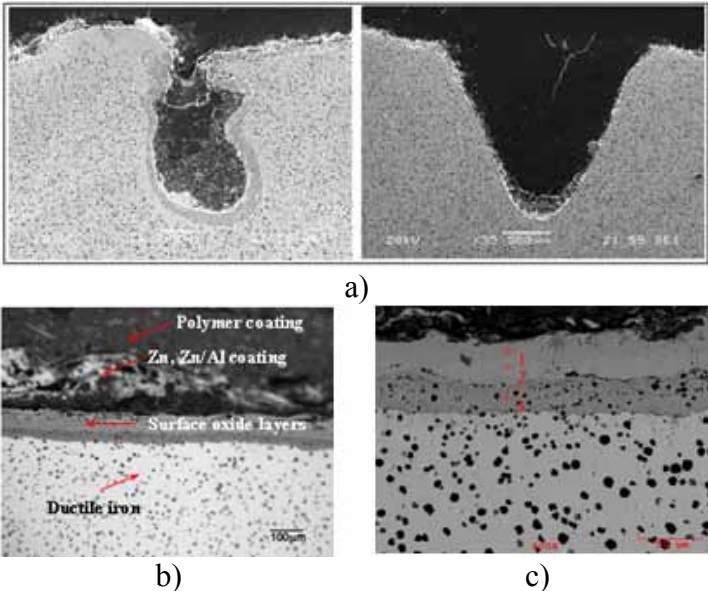
It is believed that during centrifugal casting, when ductile iron liquid is hot enough or mould temperature is high, thin Fe layer develops at early stage. Entrapped gas which is between the mould and liquid moves towards liquid and escapes from inner surface of the pipe (Fig. 1). Sometimes small canal which transfer the gas throughout the pipe forms. The wall of the canal can be covered by thin and fragmented oxide layer. SEM study showed thick iron oxide layer of the canal after annealing (Fig. 4). If the first solid layer formed on the mould is thick enough under the condition of low liquid metal temperature (or cold mould), entrapped gas can't move inside towards the pipe wall. Entrapped gas amount and pressure increase by the time and lateral curved gas hole develops. Curved, dendrite or conical shape is evidenced during experimentation. As given Fig. 6, pinhole length is as long as 1.7mm which is too much and unacceptable. Gradual decrease of number of pinholes with depth is understandable. Step reduction of volume ratio with depth implies conical shape of pinholes as sketched in Fig. 1d.

Figure 4. Pinholes and oxide layers (SEM pictures) a) Shape and depth of pinholes in transverse section. b) Oxide layers on surface without pinhole. c) Oxide layers on pinhole edge. All pictures were taken after annealing treatment.

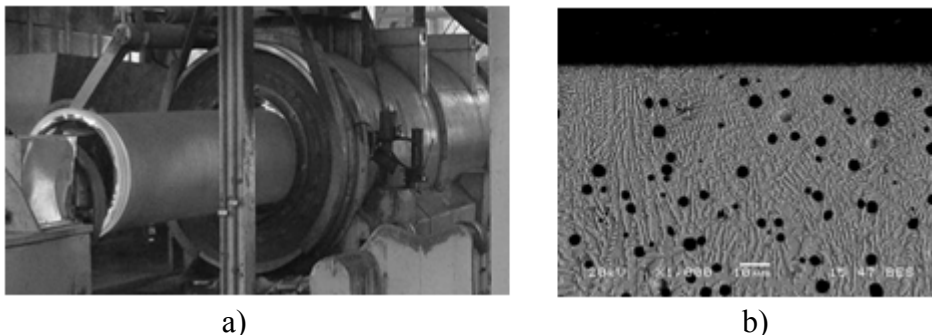
Optical and SEM microscopy study showed that ductile iron surface layer developed is nearly pure iron which is very ductile and easily deformed due to gas pressure. If conditions prevail gas penetrates inside from this hot iron layer. Iron film can be oxidized most probably at the lateral stages of solidification (Fig. 7) and during annealing (Fig. 4 and 8). Rarely, fragmented oxide films observed on the surfaces of ductile iron pipes. It is clear from Fig. 8 that oxide film is rather thick, if the heating temperature is high and period is long enough (~950°C, ~1h).

Figure 7. As-cast ductile iron pipe surface a) Hot surface of pipe during the removal from centrifugal casting machine. b) SEM microstructure of heavily etched surface and internal section as-cast ductile iron pipe (Before annealing). Spherical graphite and carbide-rich matrix are evident. Top end of cast surface is covered by oxide film with a few micrometer thicknesses.

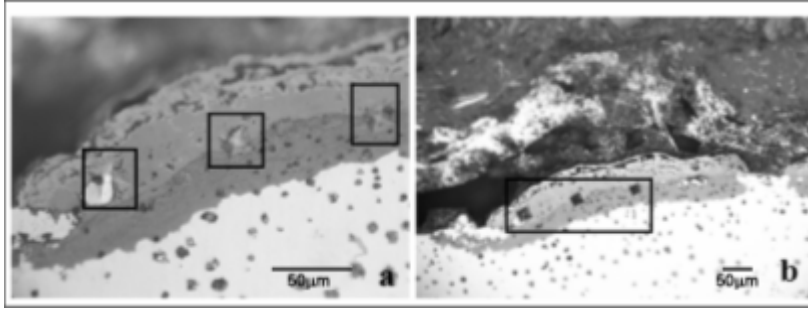
Around pinholes and on all the surfaces three oxide layers were recognized but there were no clear boundary between the layers (Fig. 8). EDS tests supported these findings. While outer surface layer is oxygen rich, the layer nearby ductile matrix is oxygen poor. Total thickness of oxide layer was approximately 80 μm. The thicknesses of each layer were more or less equal. Fragmented surface oxides and other two layers with color differences can be seen in Fig. 4 and 8. EDS analysis is given in Fig. 5. Present result was compared with previous findings [8-10]. The research study made by Horn [10] measured total thickness of 143 μm with similar layers and structures observed at present research. Rather low thickness experienced in present work is due to different heat treatment and temperature.

Figure 8. Layers of annealing oxides and indenter traces. Mean values (HV): ductile iron substrate (below matrix)= 240 ± 15 , inner oxide layer(right trace)= 480 ± 25 , middle oxide layer(middle trace)= 380 ± 27 and top oxide layer(left trace)= 320 ± 40 .

The hardness tests gave different values in different layers. Although, big hardness deviation was available in each layer, there are clear differences in morphology and hardness of layers as expected. Since oxide layer thickness was so small and upper layer was rather fragmented, taking the accurate measurement was difficult. Hardness of oxide in first layer was approximately 480HV which is 2 times higher than ductile iron matrix (240HV).
