DUCTILE IRON PIPE SURFACE CHARACTERIZATION AND PINHOLE FORMATION

**Prof. Dr. Fevzi YILMAZ,
Özgür CEVHER (M.Sc.) and Mustafa BAYRAKTAR (M.Sc.)**

ABSTRACT

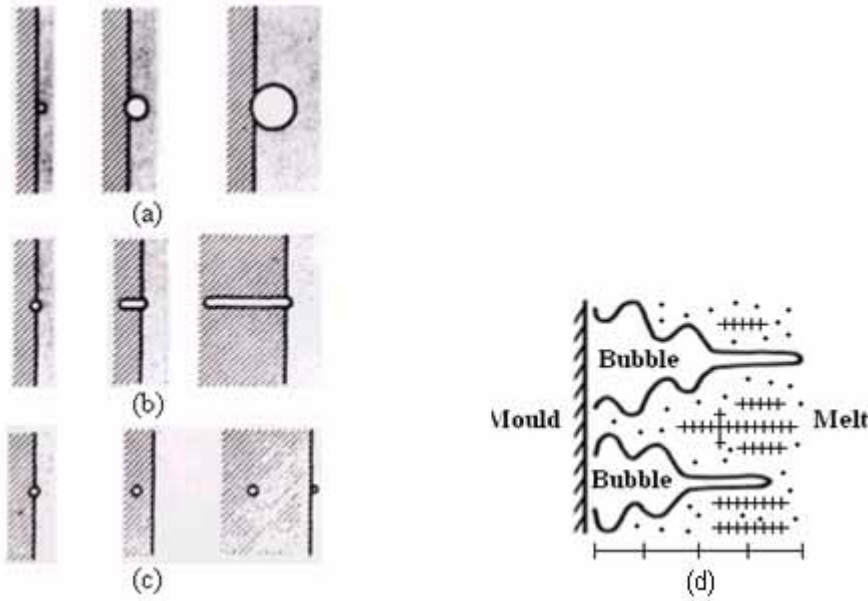
Figure 1. Pinhole formation [12]. a) Slow growth rate of solid layers. Bubble can move with the interface behavior of pushing (no pinhole left in the casting). b) Intermediate growth of solid layer. Bubble can become incorporated into the interface to grow as an elongated pinhole (surface pinholes on casting). c) Fast growth of solid layer. Surface entrapment of pinholes which can be rapidly overgrown by the interface (small holes separated in casting). d) Sketch drawn at present work. Surface pores growing together from a mould surface of high gas content in centrifugal casting. Growing front elongates into a melt.

It is believed that during centrifugal casting, when ductile iron liquid is hot enough or mould temperature is high, thin Fe layer develops at early stage. Entrapped gas which is between the mould and liquid moves towards liquid and escapes from inner surface of the pipe (Fig. 1). Sometimes small canal which transfer the gas throughout the pipe forms. The wall of the canal can be covered by thin and fragmented oxide layer. SEM study showed thick iron oxide layer of the canal after annealing (Fig. 4). If the first solid layer formed on the mould is thick enough under the condition of low liquid metal temperature (or cold mould), entrapped gas can't move inside towards the pipe wall. Entrapped gas amount and pressure increase by the time and lateral curved gas hole develops. Curved, dendrite or conical shape is evidenced during experimentation. As given Fig. 6, pinhole length is as long as 1.7mm which is too much and unacceptable. Gradual decrease of number of pinholes with depth is understandable. Step reduction of volume ratio with depth implies conical shape of pinholes as sketched in Fig. 1d.

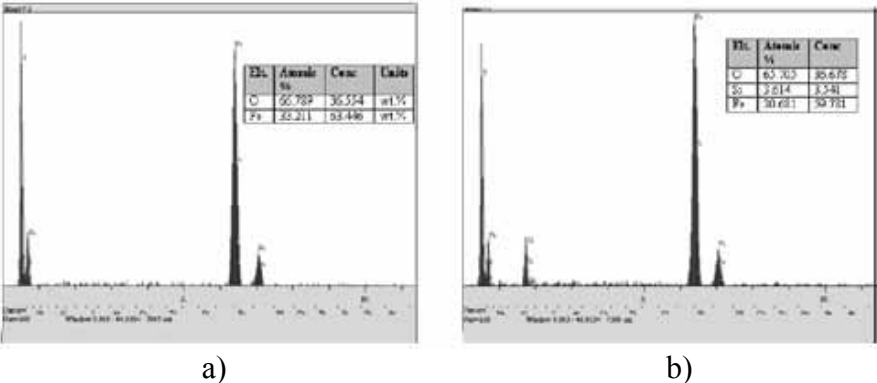
Figure 5. EDS pattern of sample given in Figure 4c. a) Point 2, b) Point 3

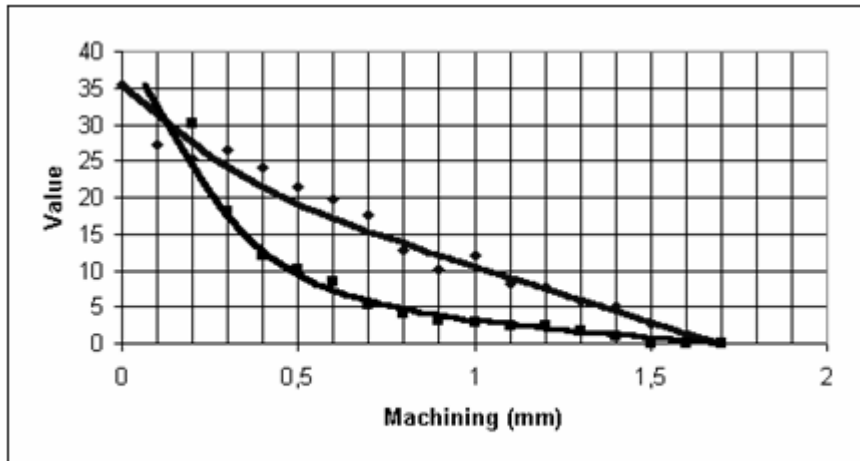
■ — Pinhole Volume Fraction (%)
 ◆ — Number of Pinhole (N/1000mm²)

Figure 6. Changing the number and volume fraction of pinholes with machining depth from the surface.
